### PAINT DEFECT ANALYSIS WITH VILEDON FILTERCAIR IN THE BAVARIAN BMW GROUP FACTORY

#### Initial situation

#### The Viledon® solution

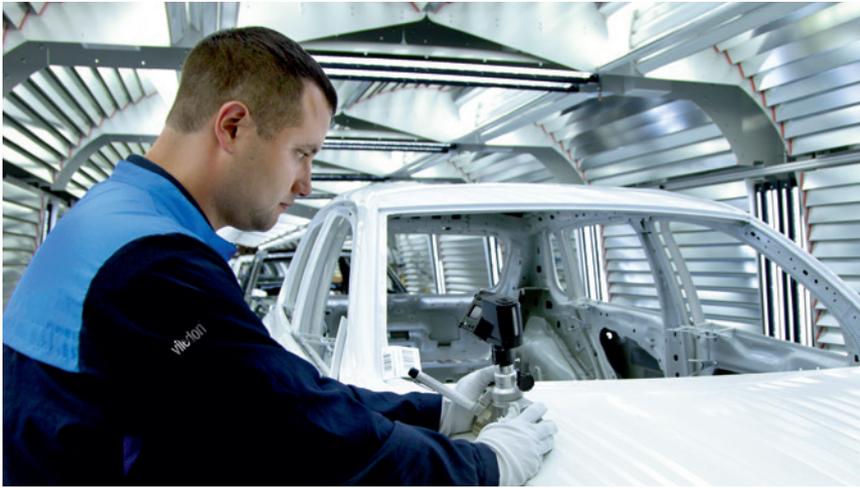
Comprehensive analyzes of the painting process and the paint defects were carried out directly on site

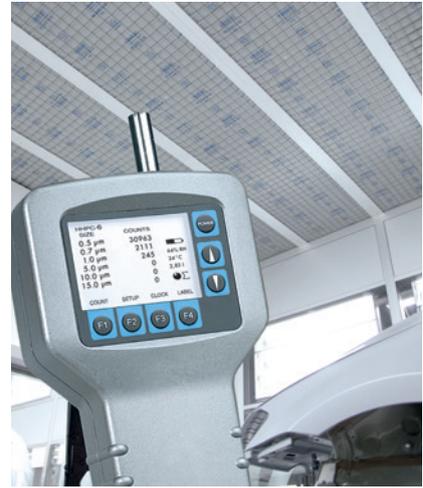
Raster measurement of sink rates in the spray booth
